No.  
00087

### PFO Tank Inspection

| Customer | Location Name | Address |
|---|---|---|
| 4Refuel | York1 Scarborough | 300 Nugget Ave.<br>Scarborough<br>Ontario |

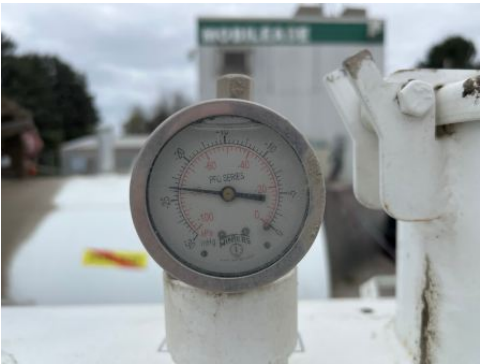
Other Photo

Comments on additional picture:  
Vacuum gauge good
