### PFO Tank Inspection

| 4Refuel | York1 Whitby | 113 Warren Road<br>Whitby<br>Ontario |

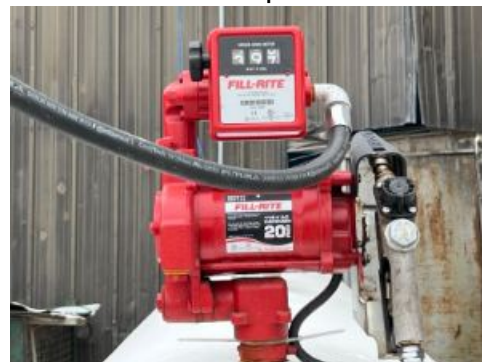
| Dyed Diesel | 120 Volt Pump | Normal | Pump connection ok |
