No.  
00086

### PFO Tank Inspection

| Customer | Location Name | Address |
|---|---|---|
| 4Refuel | York1 Scarborough | 300 Nugget Ave.<br>Scarborough<br>Ontario |

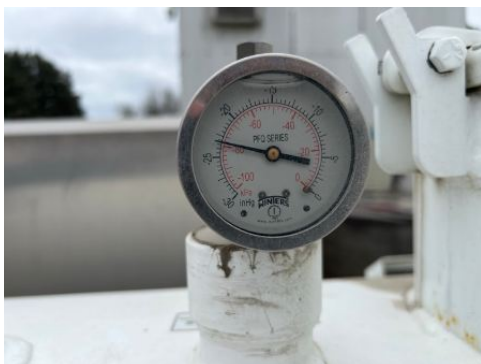
Other Photo

Comments on additional picture:  
Vacuum gauge good
